4.0 EXISTING CONDITIONS

QEW Credit River Bridge

Preliminary Design and Class Environmental Assessment Study

Transportation Environmental Study Report

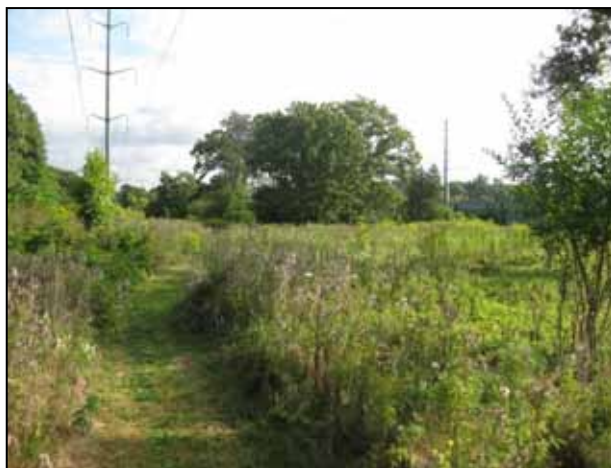
Photo 4-1. View east along hydro corridor, prior to the construction of the access road

Photo 4-1 depicts the cultural meadow (1a on **Exhibit 4-2**) located west of the Credit River and north of the QEW. Note: this area is currently occupied by the construction access road for the Credit River Bridge Holding Strategy.

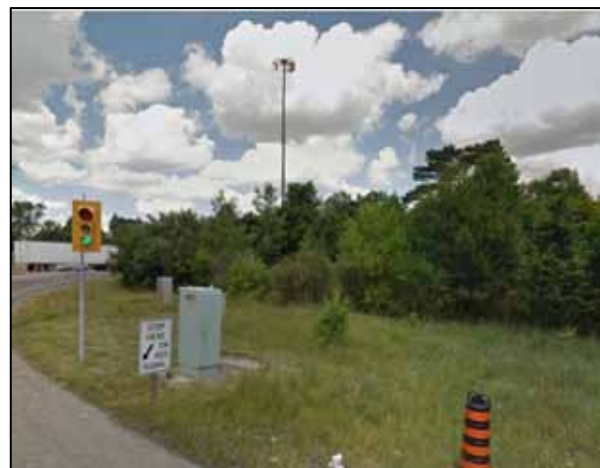
Photo 4-2. View of cultural woodland between on-ramp and Kedleston Way

Photo 4-2 depicts the Cultural Woodland (1e) located between the existing QEW on-ramp and Kedleston Way. This woodland originates from highway landscape plantings that have matured, seeded and created a somewhat natural wooded area.

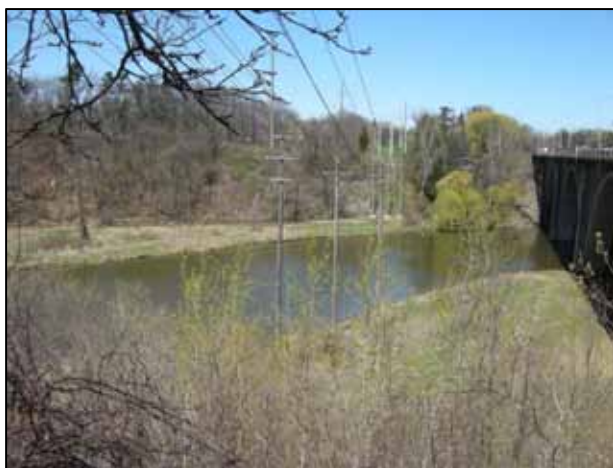
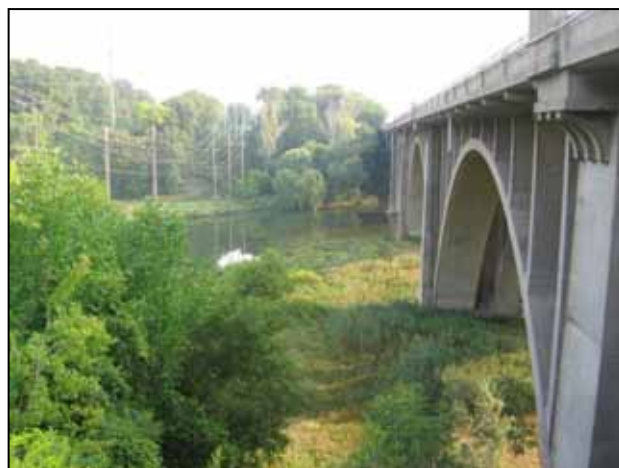
Photos 4-3 a and b. View east along hydro corridor, early season and mid-season. Vegetation communities of note include: Unit 2c young, Manitoba Maple-dominated cultural woodland in the NW quadrant (foreground) and in the NE quadrant (between the hydro corridor and the bridge); Unit 2e meadow marsh and cultural meadow floodplain vegetation in the NW quadrant (foreground); Unit 2l meadow marsh floodplain vegetation in the NE quadrant, north of the hydro corridor.

Photos 4-3 to 4-8 illustrate existing conditions and vegetation community types within Vegetation Unit 2 in the NW, NE, SW and SE quadrants.

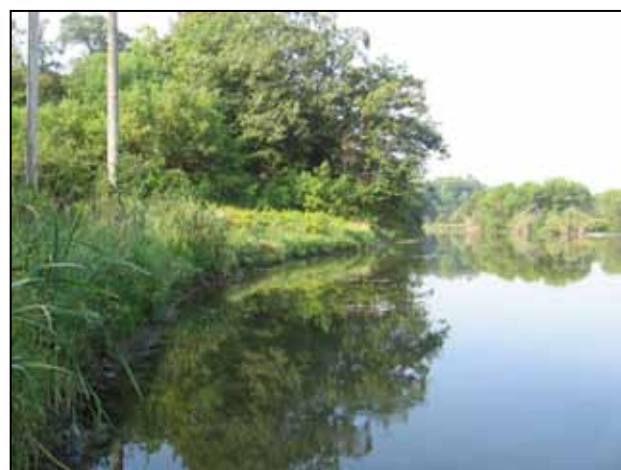
Photo 4-4. View north along west river bank in the northwest quadrant. A small patch of submergent vegetation is located within an eddy along the west bank. The community is dominated by the Regionally Rare Flatstem Pondweed; the only submergent vegetation community located within the study area.

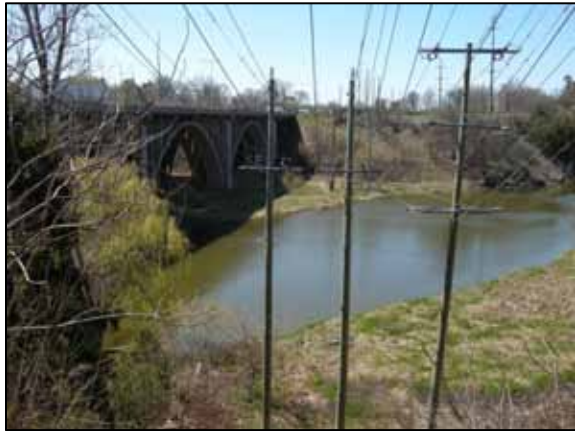
Photo 4-5. View west to the northwest quadrant along the hydro corridor. Note seasonally flooded shallow marsh (Unit 2h) in the NE quadrant (foreground).

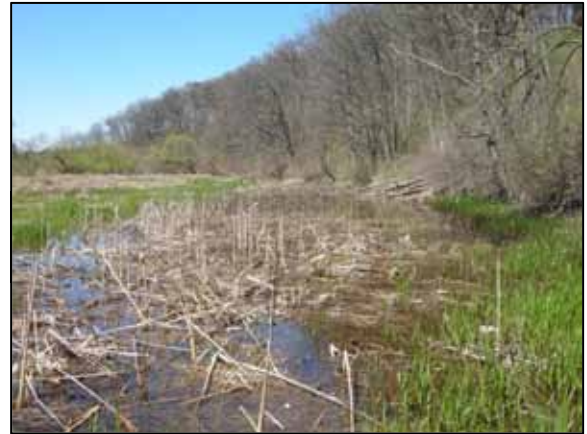
Photo 4-6. View of Unit 2h, a seasonally flooded shallow marsh community within the NE quadrant at the base of the valley slope.

The small shallow marsh (Unit 2h on **Exhibit 4-2**, Photo 4-6) located in the NE quadrant may be used by Snapping Turtles as hibernaculum. This shallow marsh sits in a depression along the base of the valley slope and appears to seasonally flood in spring. The substrate is organic with woody debris present. Three adult Snapping Turtles were observed during field surveys in the spring of 2011 and 2012 basking/foraging (Photo 4-13) in this area, which would suggest possible hibernation emergence from this location. The turtles were not

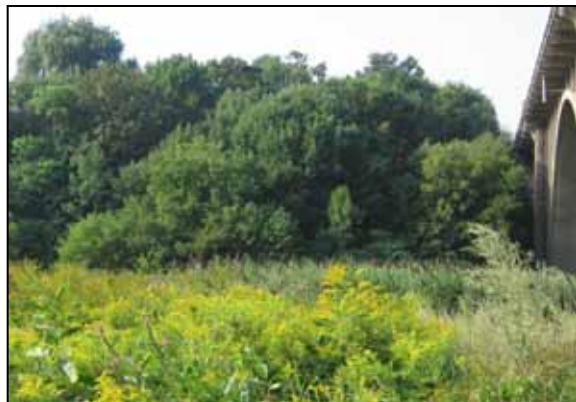
Photo 4-7. View west to southwest quadrant – floodplain vegetation (within the PSW boundary) and west valley slope. This valley slope forest is higher quality/less disturbed and therefore considered more sensitive than the valley slope vegetation in the 3 other quadrants.

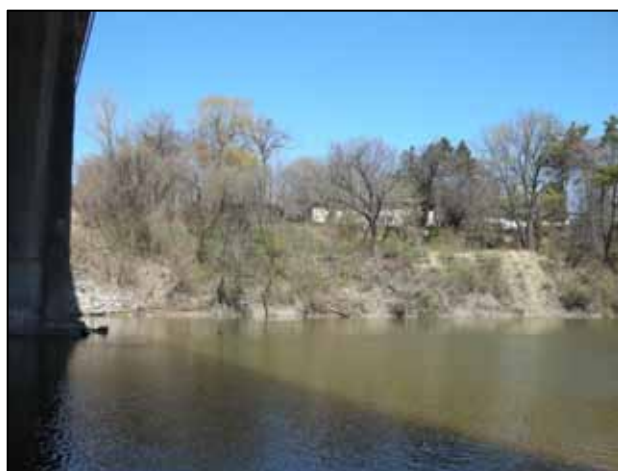
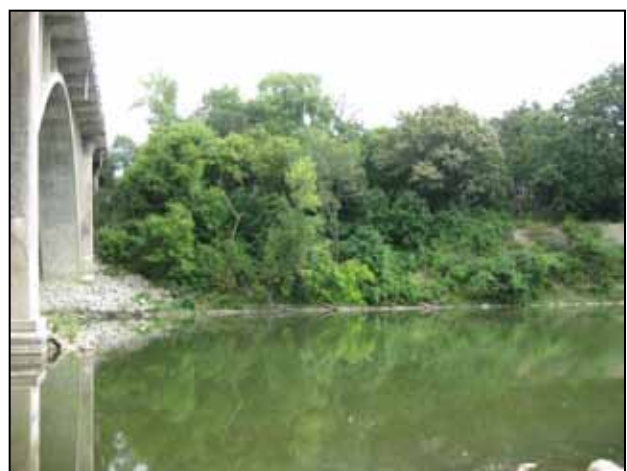
Photo 4-8 a and b. View east to southeast valley slope cultural woodland located along rear lot line in the SE quadrant.

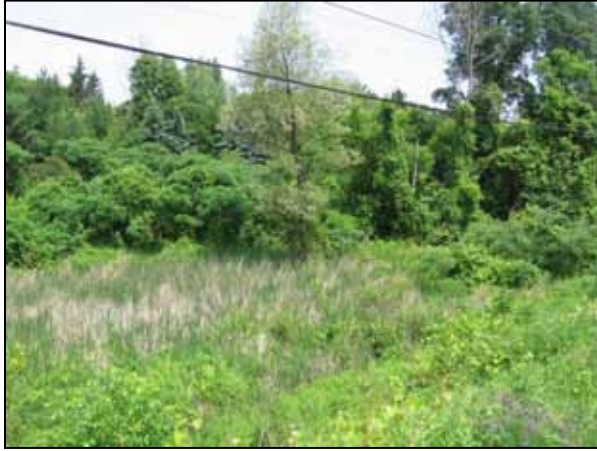
Photo 4-9. Units 3a (Sumac dominated Cultural Thicket) and 3c (Cattail Shallow Marsh) along Stavebank Creek, north of Premium Way.

Unit 3 is an assemblage of disturbed/culturally-influenced vegetation communities along Stavebank Creek. All ELC communities within Unit 3 are roadside communities surrounded by residential development and are highly disturbed.

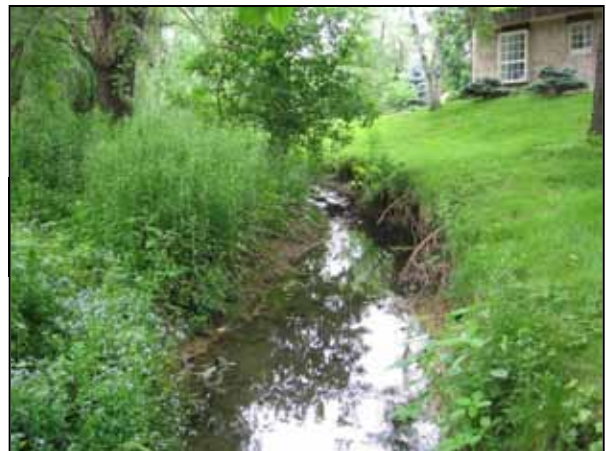
Photo 4-10. Disturbed lowland forest vegetation and manicured lawn along Kenolli Creek south of the existing QEW ROW (Unit 4b).

Unit 4 is a narrow strip of cultural meadow and lowland forest along Kenolli Creek north and south of the QEW. This unit also includes two hedgerows adjacent to the Kenolli Creek crossing, north of the QEW.

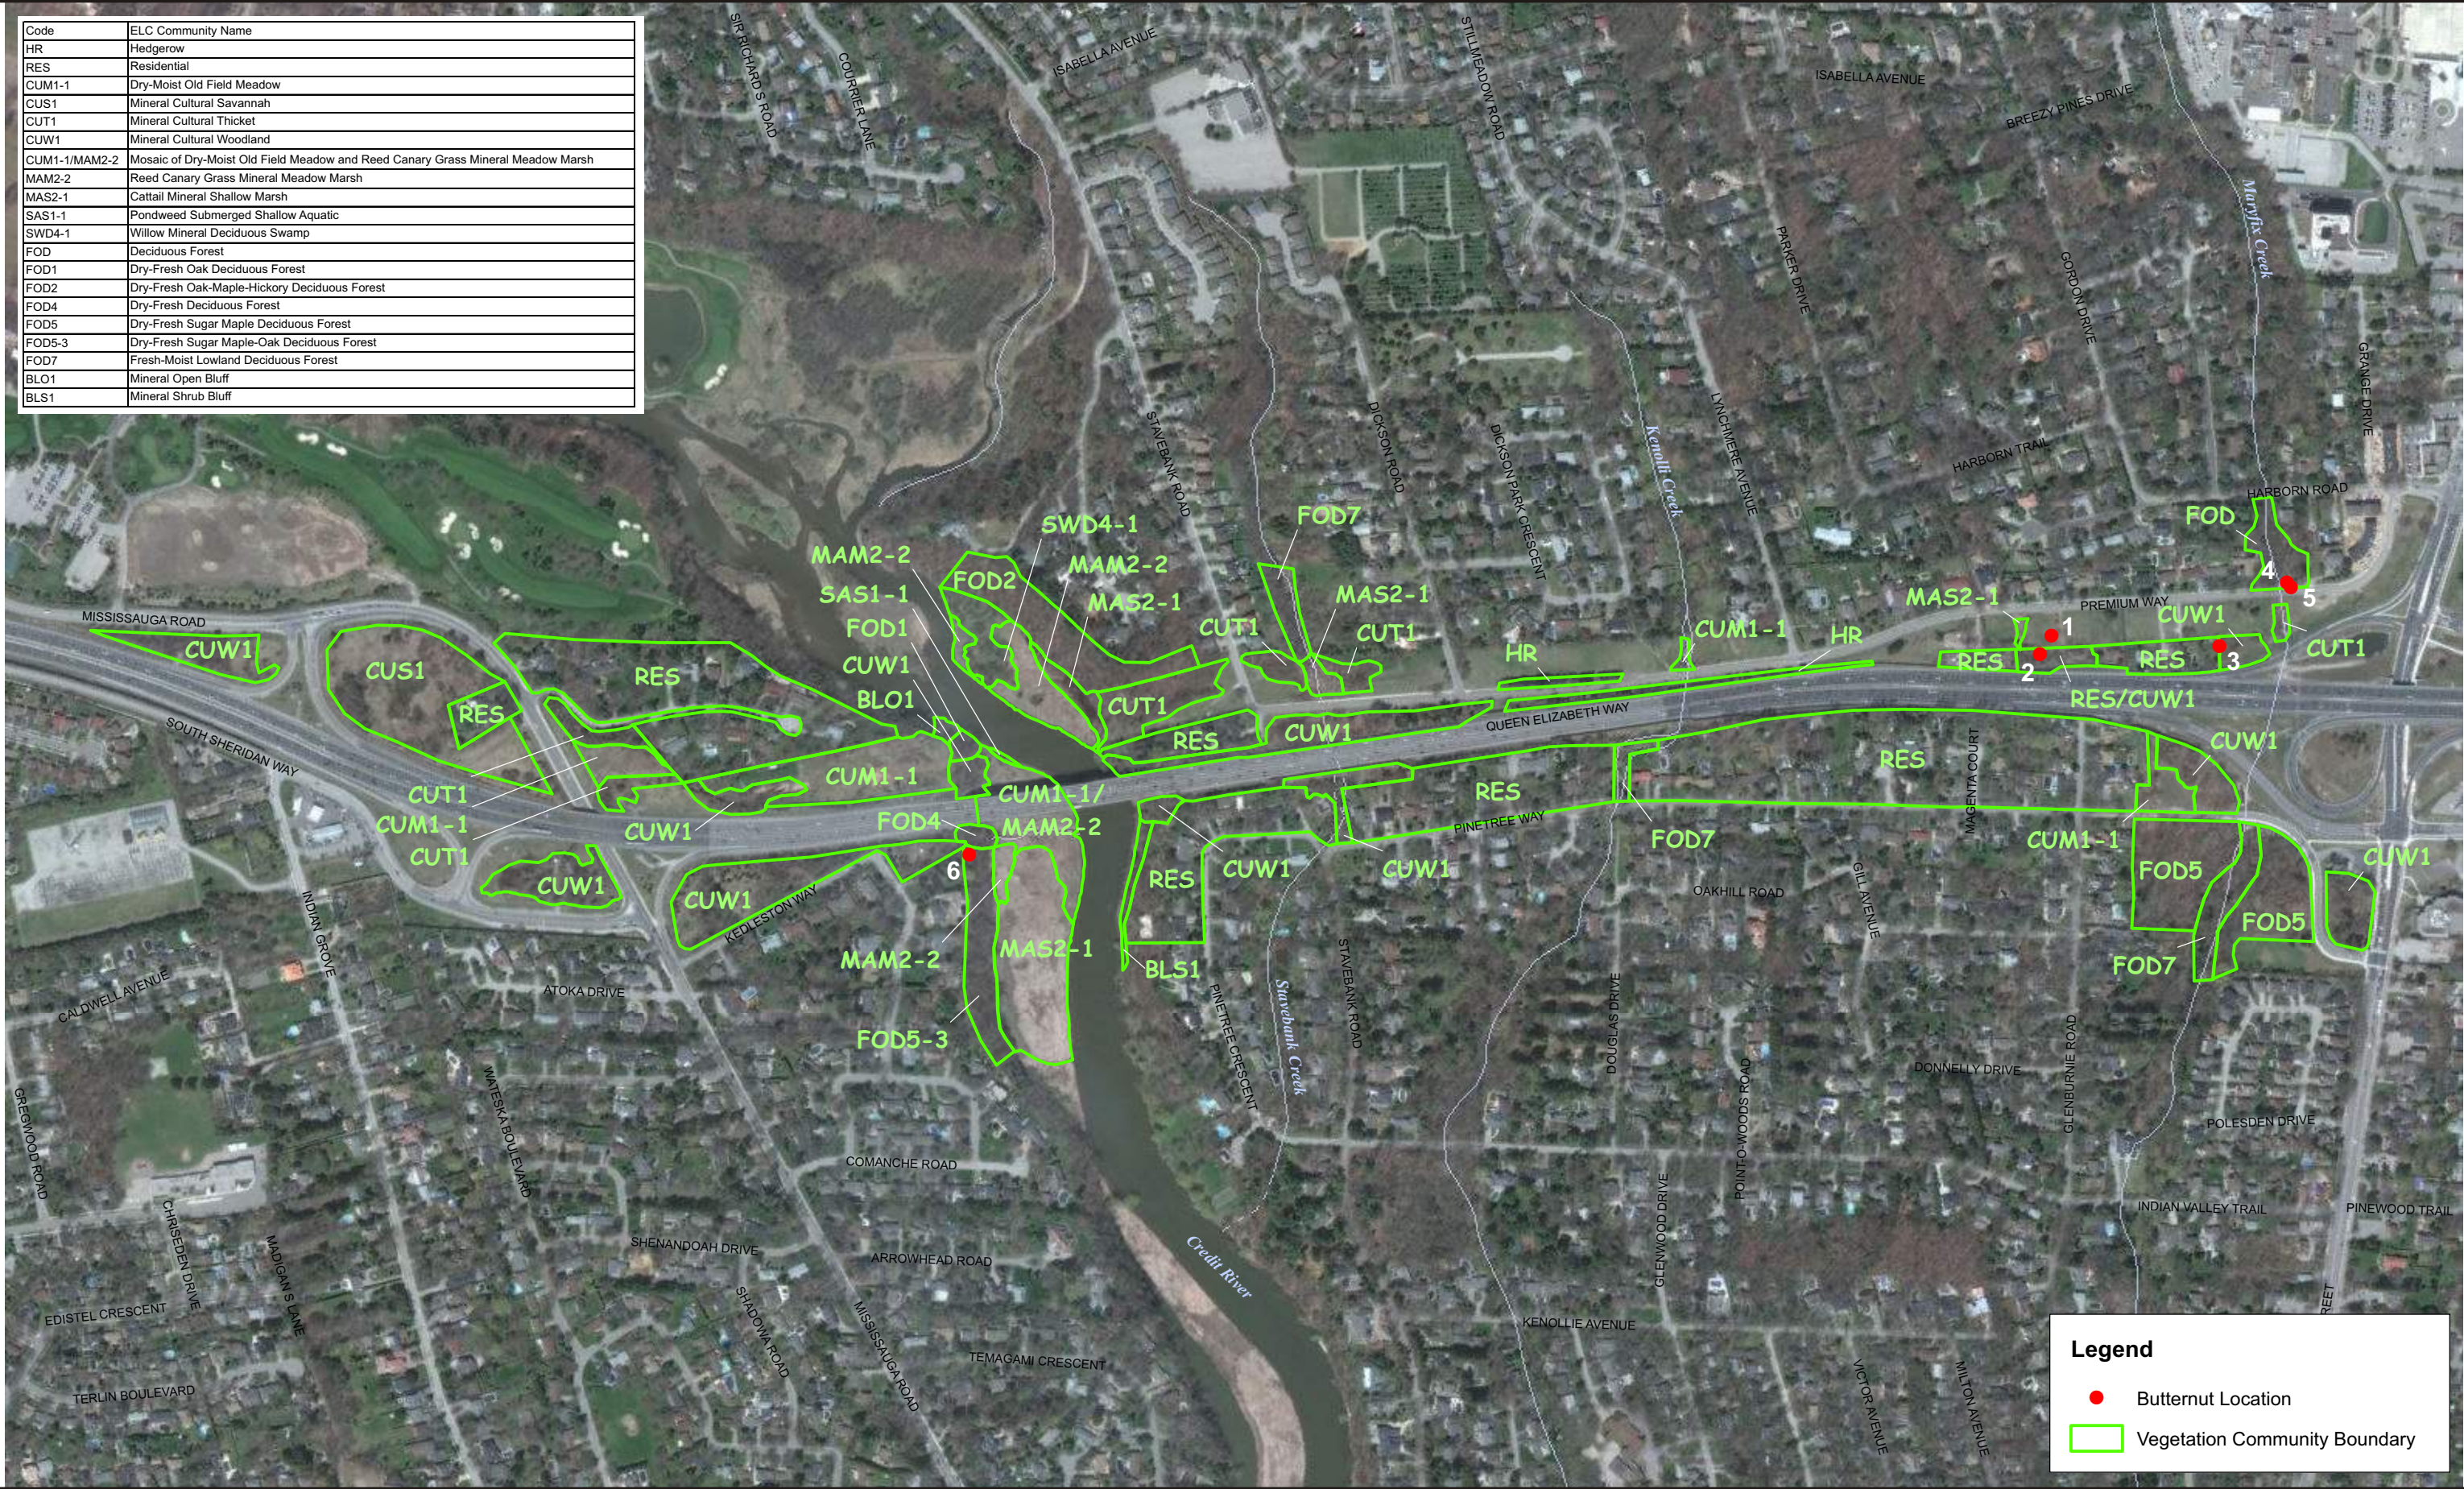
A total of 16 Ecological Land Classification (ELC) vegetation community types were identified within four (4) general Vegetation Units as depicted on **Exhibit 4-2**. The broad Vegetation Units are described below and the individual ELC community types are identified on **Exhibit 4-2** and described in detail in **Appendix B**. None of the vegetation communities observed are considered rare in Ontario (per NHIC Biodiversity Explorer website).

Code	ELC Community Name
HR	Hedgerow
RES	Residential
CUM1-1	Dry-Moist Old Field Meadow
CUS1	Mineral Cultural Savannah
CUT1	Mineral Cultural Thicket
CUW1	Mineral Cultural Woodland
CUM1-1/MAM2-2	Mosaic of Dry-Moist Old Field Meadow and Reed Canary Grass Mineral Meadow Marsh
MAM2-2	Reed Canary Grass Mineral Meadow Marsh
MAS2-1	Cattail Mineral Shallow Marsh
SAS1-1	Pondweed Submerged Shallow Aquatic
SWD4-1	Willow Mineral Deciduous Swamp
FOD	Deciduous Forest
FOD1	Dry-Fresh Oak Deciduous Forest
FOD2	Dry-Fresh Oak-Maple-Hickory Deciduous Forest
FOD4	Dry-Fresh Deciduous Forest
FOD5	Dry-Fresh Sugar Maple Deciduous Forest
FOD5-3	Dry-Fresh Sugar Maple-Oak Deciduous Forest
FOD7	Fresh-Moist Lowland Deciduous Forest
BLO1	Mineral Open Bluff
BLS1	Mineral Shrub Bluff

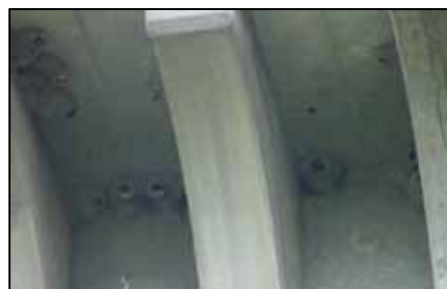
Photo 4-11. Cliff Swallow nests on the Credit River Bridge.

Birds observed nesting or attempting to nest under the Credit River Bridge in 2011 and 2012 included: House Sparrow, Northern Rough-winged Swallow, Cliff Swallow, and European Starling. Eastern Phoebe was observed close to the bridge and exhibited territorial and nesting behaviour that would suggest nesting sites may be present either adjacent to the bridge or on the bridge itself; however, no confirmed evidence of nesting on the bridge was observed during field surveys.

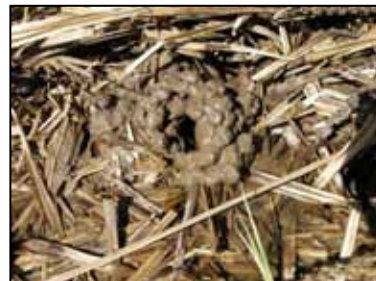
Photo 4-12. Mud chimney observed in Unit 2h, in the NE quadrant.

The presence of mud “chimneys” created by semi-terrestrial crayfish (species unknown) were observed during early spring surveys in 2011 and 2012 in the Reed Canary Grass mineral shallow marsh (Unit 2h) located at the base of the valley slope in the NE quadrant of the study area. The preferred habitat of chimney crayfish (meadows and edges of shallow marshes) is common in the broader area (i.e., habitat is not limited to the areas within the study limits. Further discussion is provided in **Section 4.1.4.1**.

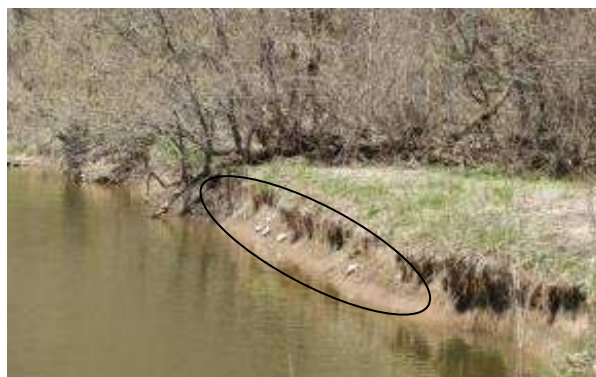
Photo 4-14. Northern Map Turtles basking on the east river bank, north of the Credit River Bridge, adjacent to the island.

Ten Northern Map Turtles were observed during field surveys. The majority of the observations occurred in early spring when the turtles were basking along the exposed sandy east bank approximately 160 m, adjacent to the island north of the Credit River bridge (Photo 4-14). This is a good indication that Northern Map Turtles utilize areas upstream of the bridge where suitable hibernation and nesting habitat appears to be present. Preferred hibernation habitat for this species includes river depressions of sand and gravel substrate with scattered logs and rocks; preferred nesting habitat includes unshaded sandy or loamy soils (Ernst & Lovich, 2009; Harding, 1997).

- Erosion was observed along the steep valley wall in the NW and SE quadrants. Bank undercutting was observed along the east bank in the NE quadrant approximately 40 m upstream of the bridge (Photo 4-14).

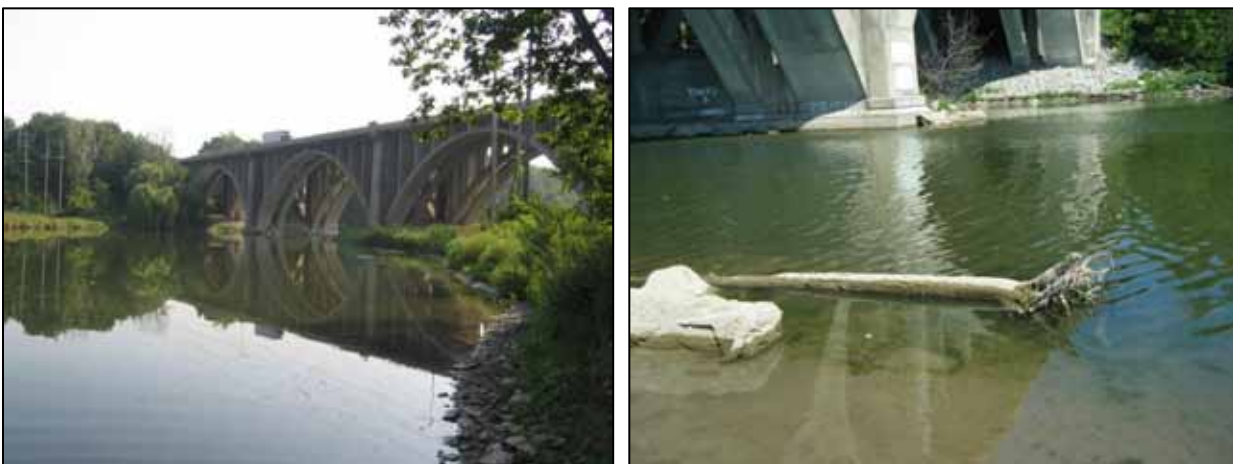
Photos 4-16 a and b. Credit River Bridge crossing location characterized by “flat” morphology, fine substrates along the west bank and armouring/erosion control along the east bank. Instream cover includes occasional boulders, woody debris and small patches of submergent vegetation. 5-16 a captures the view from upstream of the bridge. 5-16 b captures the view immediately downstream of the bridge.

- Depth of flow at the time of the survey ranged from 10 cm along the banks to over 1.5 m mid-channel.
- Channel bank height ranges from 0.8 m to 1.35 m, however in the SW quadrant the steep, wooded valley wall rises up approximately 15 m from the floodplain. A steep valley wall (approximately 25 m in height) was also observed along the river channel in the NW quadrant.

- Instream cover includes rubble, the occasional boulder, undercut banks and woody debris, and small patches of instream vegetation (e.g., cattail, Reed Canary Grass, sedge *spp.*, and pondweed *sp.*).

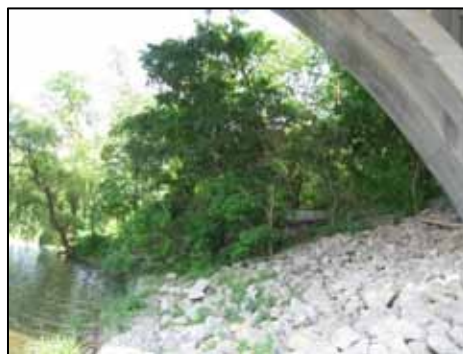
Photo 4-17: Armouring along the east bank, under the bridge, and nearby drainage pipe outlet.

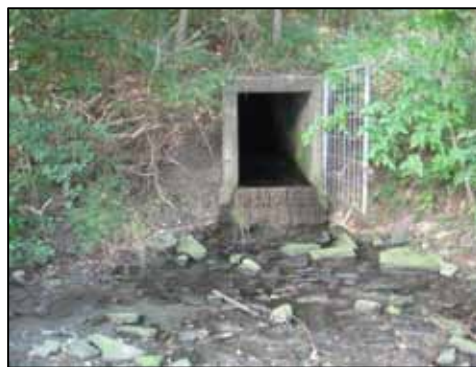
Photo 4-18: A storm sewer outlet at the base of the west valley slope is the origin of the Credit River tributary in the SW quadrant.

- The tributary originates at a concrete box culvert storm sewer outfall (1.75 m height x 1.3 m width) located at the toe of the west valley slope (Photo 4-18).
- The channel cuts through the cattail marsh in the floodplain and outlets to the Credit River just downstream of the Credit River Bridge.
- The bankfull width of the upstream section of the channel ranges from 2 m to 2.5 m. In the downstream section, bankfull width ranges from 3 m and 3.5 m. Bank heights range from 0.6 to 0.8 m. Flow depth ranged from 3 cm to 10 cm in the upstream section and between 10 cm and 30 cm in the downstream section.

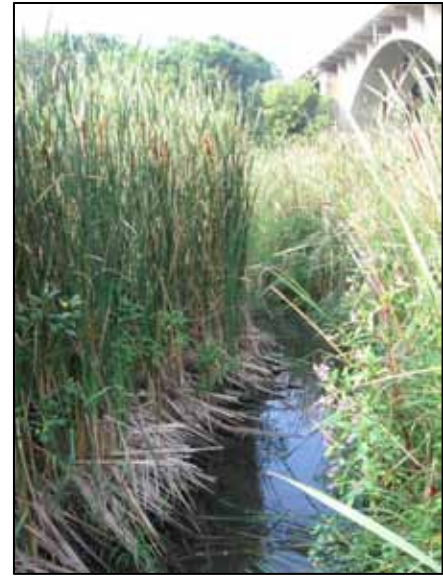
Photo 4-19: Tributary near the outlet at the Credit River.

- Morphology is predominantly flat with a small riffle and shallow pool at the upstream end, near the storm sewer outlet. Substrate in the upstream section is comprised of sand, shale, gravel and rubble. Substrates along the downstream section are finer and dominated by sand and silt. With the exception of some local scouring at the storm sewer outlet, there is very little erosion along the channel.
- Instream cover includes bank undercutting as well as some instream vegetation (e.g., cattail, Reed Canary Grass).
- Riparian vegetation in the upstream section is dominated by goldenrod (old field species) with some cattail and Reed Canary Grass. Further downstream cattail becomes dominant with Jewelweed and Purple Loosestrife.

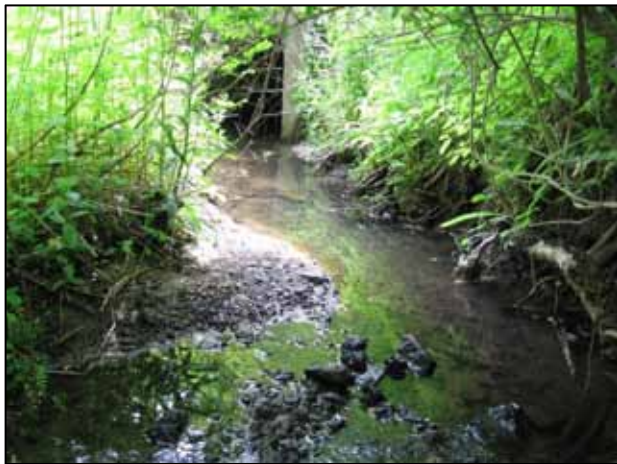
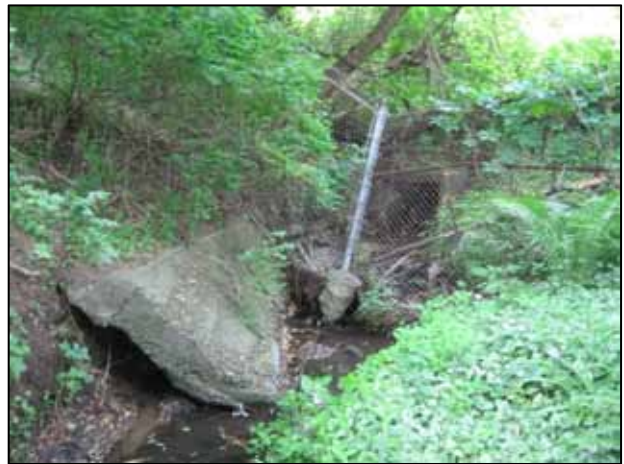
Photos 4-20 a and b. Stavebank Creek at the QEW culvert inlet (left) and outlet (right).

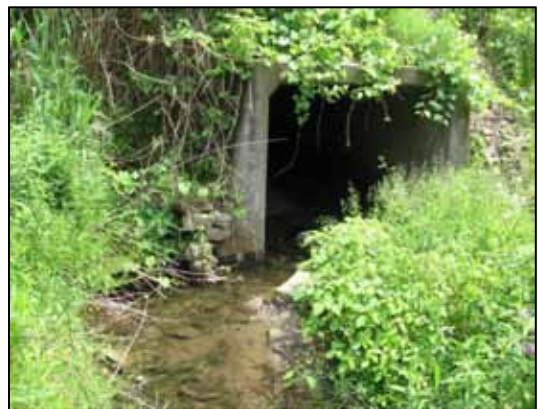
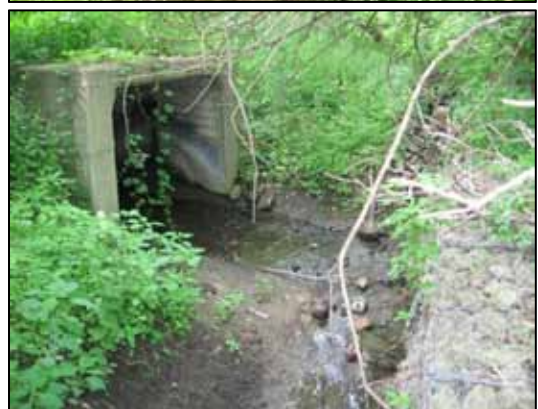
Photos 4-21 a and b. Stavebank Creek at the QEW culvert inlet (top) and outlet (bottom).

- The channel reach up and downstream of the QEW has a bankfull width of 2.5 m. Further downstream the channel becomes more 'U shaped' and ranges in width from 0.75 m to 1 m before it widens again near Pineway Road. The wetted width of the channel ranged from 0.5 m and 1.5 m. Bank heights range from 1 m to 1.5 m upstream of the QEW and Premium Way to 0.5 m to 0.75 m downstream of the

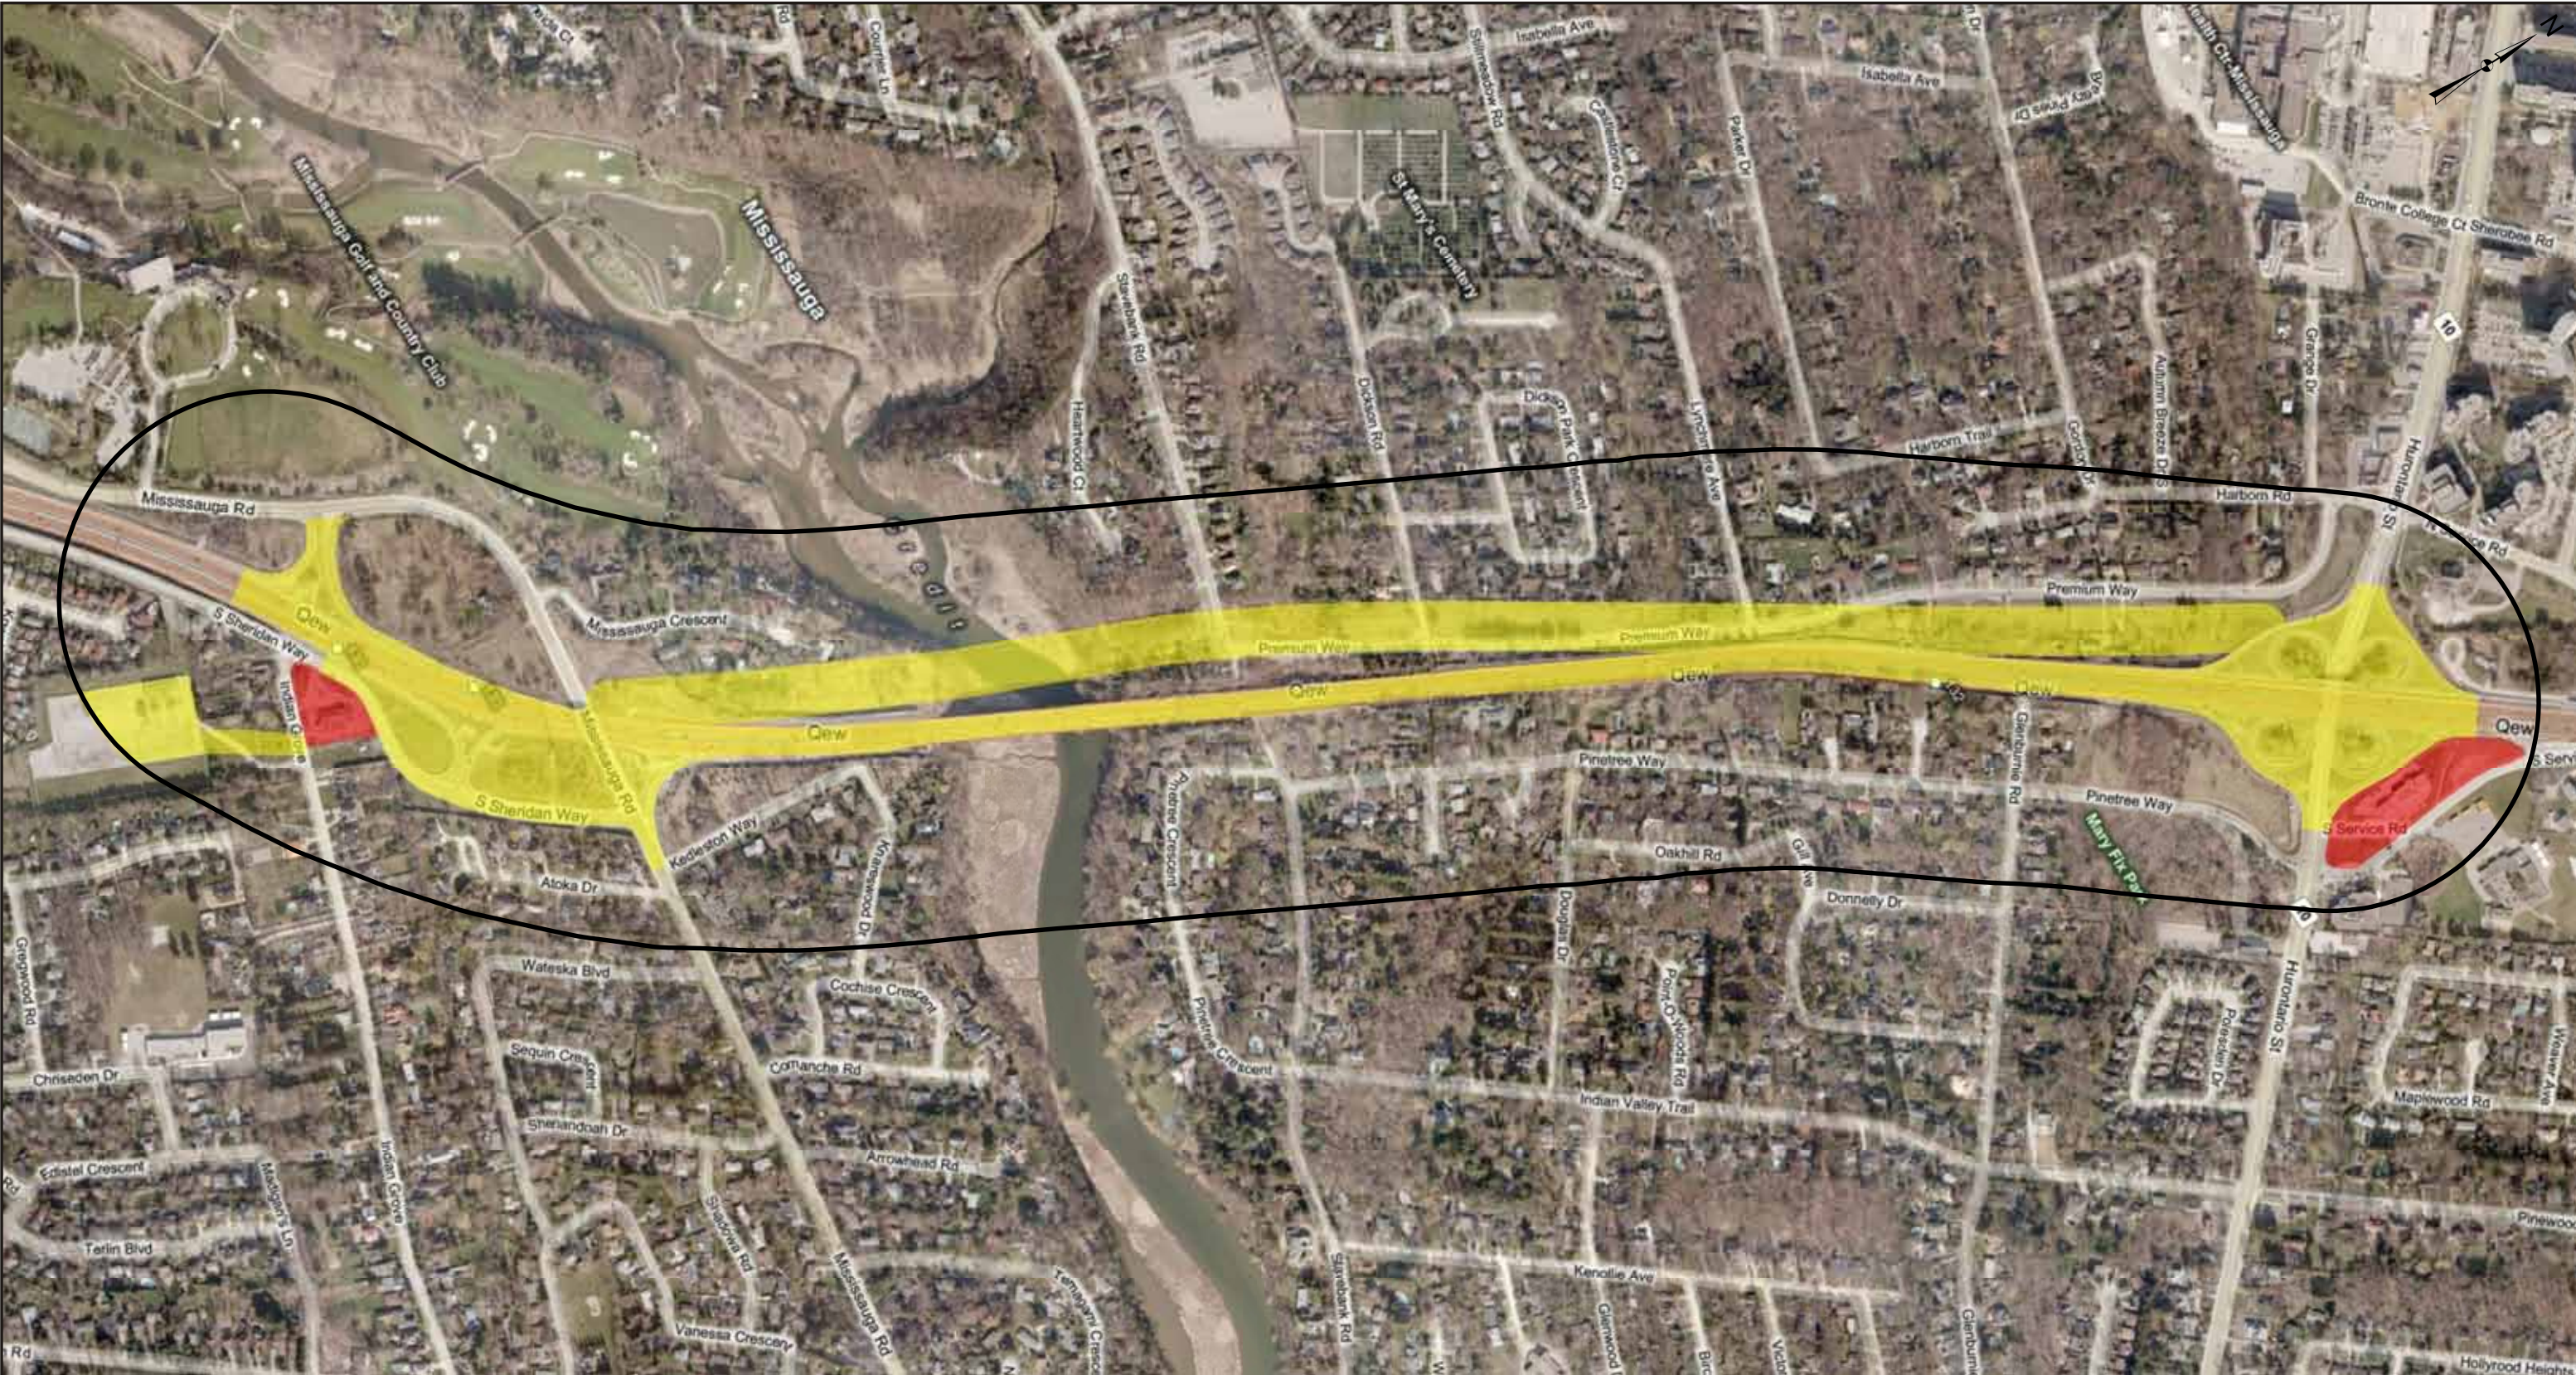
- Legend**
- Area of Moderate Concern
 - Area of High Concern
 - Study Area - 250m Buffer

- QEW Right-of-way (ROW) and interchanges – potential for shallow soil contamination from vehicle exhaust (e.g., lead and other metals), general wear and tear (e.g., heavy metals, oils and lubricants), spills and winter road maintenance activities (e.g., salt staining).

- Hydro corridor – potential for shallow soil contamination from historical spraying of vegetation with pesticides within the corridor. In addition, corrosion of the galvanized steel towers which support the electrical transmission lines can cause zinc contamination of the soil.

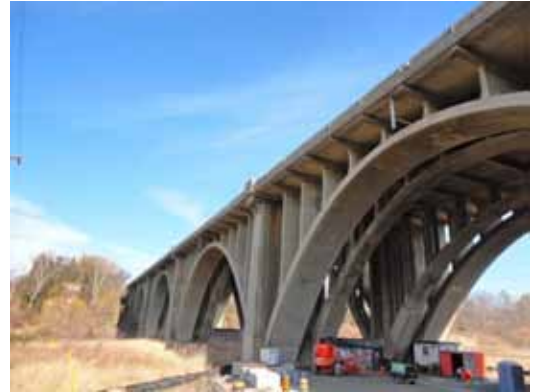
<p>[Credit River Bridge looking East.]</p>

Heritage Resource	Resource Type	Location	Description of Resource and Heritage Recognition	Digital/Aerial/Map Image
BHR	Transportation	Credit River Bridge at the QEW, City of Mississauga	<p><i>Credit River Bridge (MTO Site No. 24-203)</i></p> <ul style="list-style-type: none"> • The original open spandrel concrete arch design bridge was built in 1934. It was widened in 1960 with attention paid to matching the original design and maintaining the four arches. The bridge spanning the Credit River manages to support the natural setting. • Under MTO <i>Ontario Heritage Bridge Guideline</i> the structure achieved a score of 80 making it eligible for inclusion in the Ontario Heritage Bridge list and as a resource of Provincial Heritage Significance. • The Credit River Bridge is identified by the City of Mississauga's <i>Cultural Landscape Inventory</i> as a Special Landscape Feature, F-SLF-2. It is described as follows, <p><i>This precast concrete structure is a prominent feature within the Credit River Valley. The structure itself has architectural merit. Also important are the original lamp standards with their ER (Elizabeth Regina) logo. The entire</i></p>

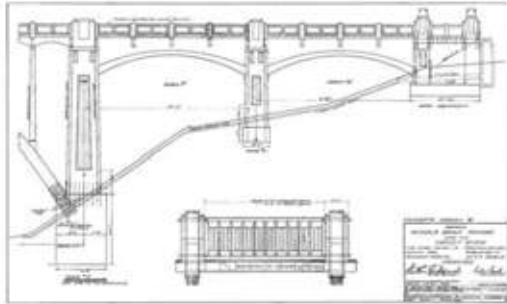
<p>[Department of Highways. Proposed Middle Road Bridge over the Credit River The King's Highway No. 10 Toronto-Hamilton, County Peel, Township, Toronto, Lot 5-8, Range 2 (November 21, 1933).]</p>

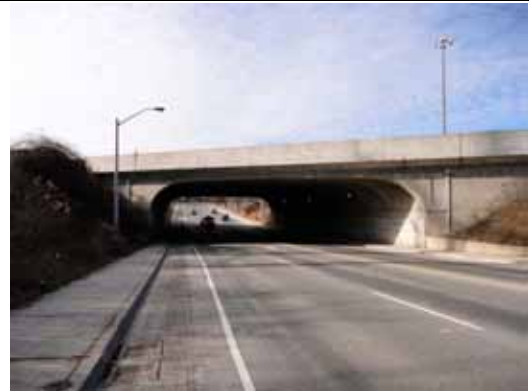
<p>[View looking to south elevation.]</p>

<p>[View looking west to front elevation.]</p>
BHR	Transportation	QEW at Mississauga Road, City of Mississauga	<p><i>Mississauga Road/QEW Overpass EBL and WBL (MTO Site No. 24-196/1 and 2).</i></p> <p>These overpasses are concrete rigid frame, T-beam, structures built in 1965 as part of a QEW interchange at Mississauga Road.</p> <p>The bridge has not been evaluated under the <i>MTO Ontario Heritage Bridge Guideline</i> evaluation process. MTO screened out the structures for heritage evaluation for this project.</p>

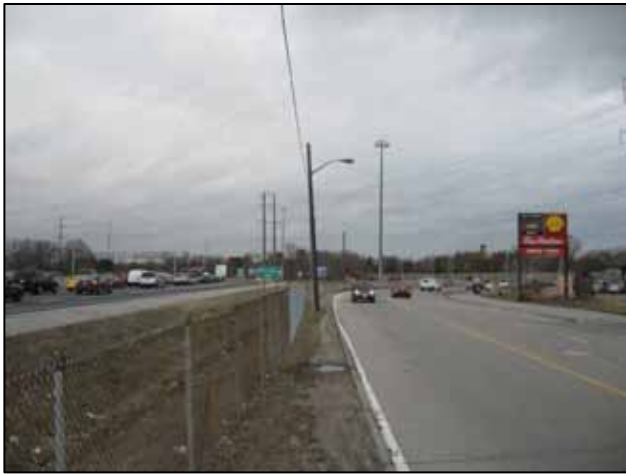
Photo 4-22: South Sheridan Way, Looking East

Mississauga with a posted speed limit of 50 km/h. In residential areas, a 5 m high noise wall separates the service road from the QEW. Photos 1 to 3 below illustrate the parallel roads within the study area. The service roads do not extend over the Credit River, resulting in discontinuities in the municipal road network. The next adjacent crossings of the Credit River are Dundas Street to the north and Lakeshore Road to the south.

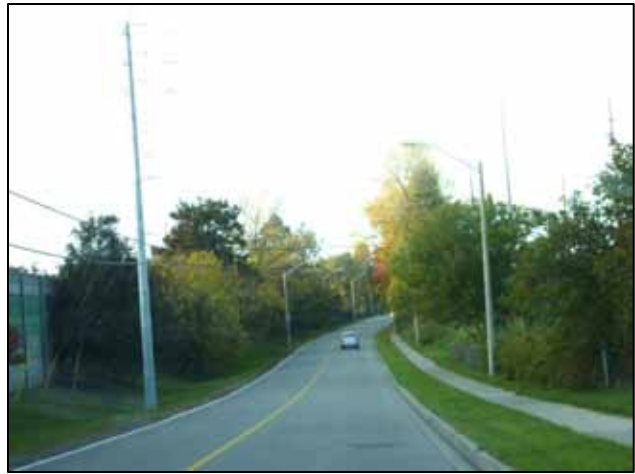
Photo 4-23: Premium Way, Looking West

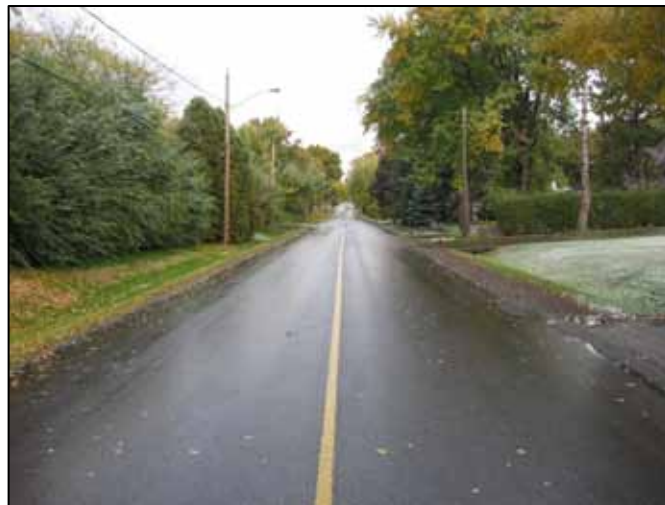
Photo 4-24: Pinetree Way, Looking East

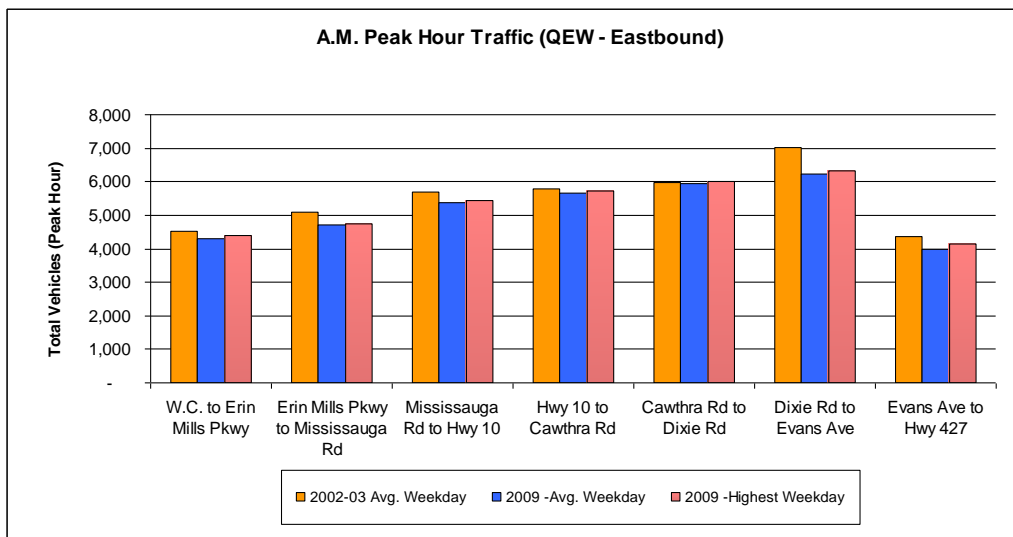
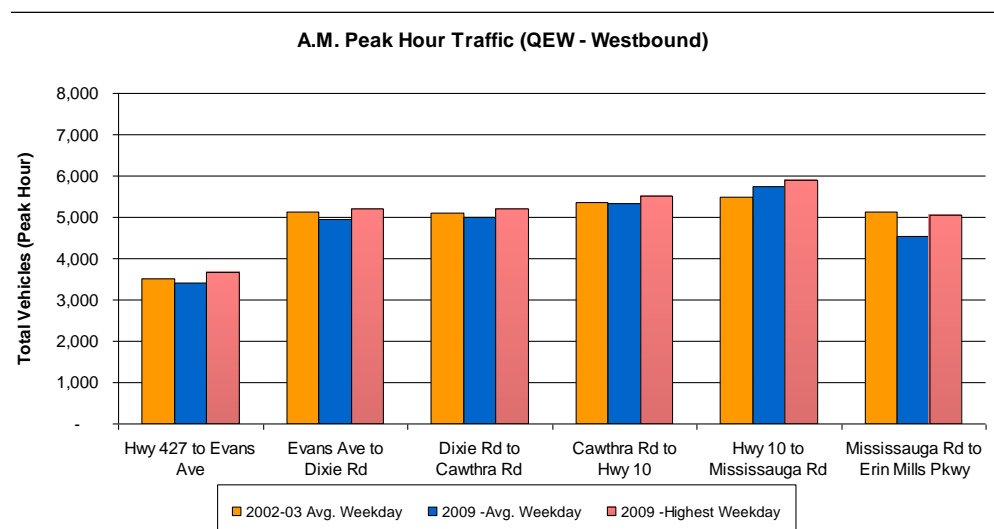
EXHIBIT 4-10: TRAFFIC GROWTH IN PEAK PERIOD (2002-2009)

Due to congestion, there has been little to no opportunity for growth in peak period peak direction travel in recent years. **Exhibit 4-10** on the following pages illustrates the historical traffic during the morning peak hour for both eastbound and westbound directions from 2002 to 2009; it shows no significant growth for the eastbound direction and only a minor increase in the westbound direction. At certain locations, peak hour traffic volume was reduced in Year 2009 as compared to Year 2002. The construction activities at Hurontario Street Interchange may be the reason for reduced traffic on the QEW mainline, where speed limit through this area was reduced to 80 km/h during construction.

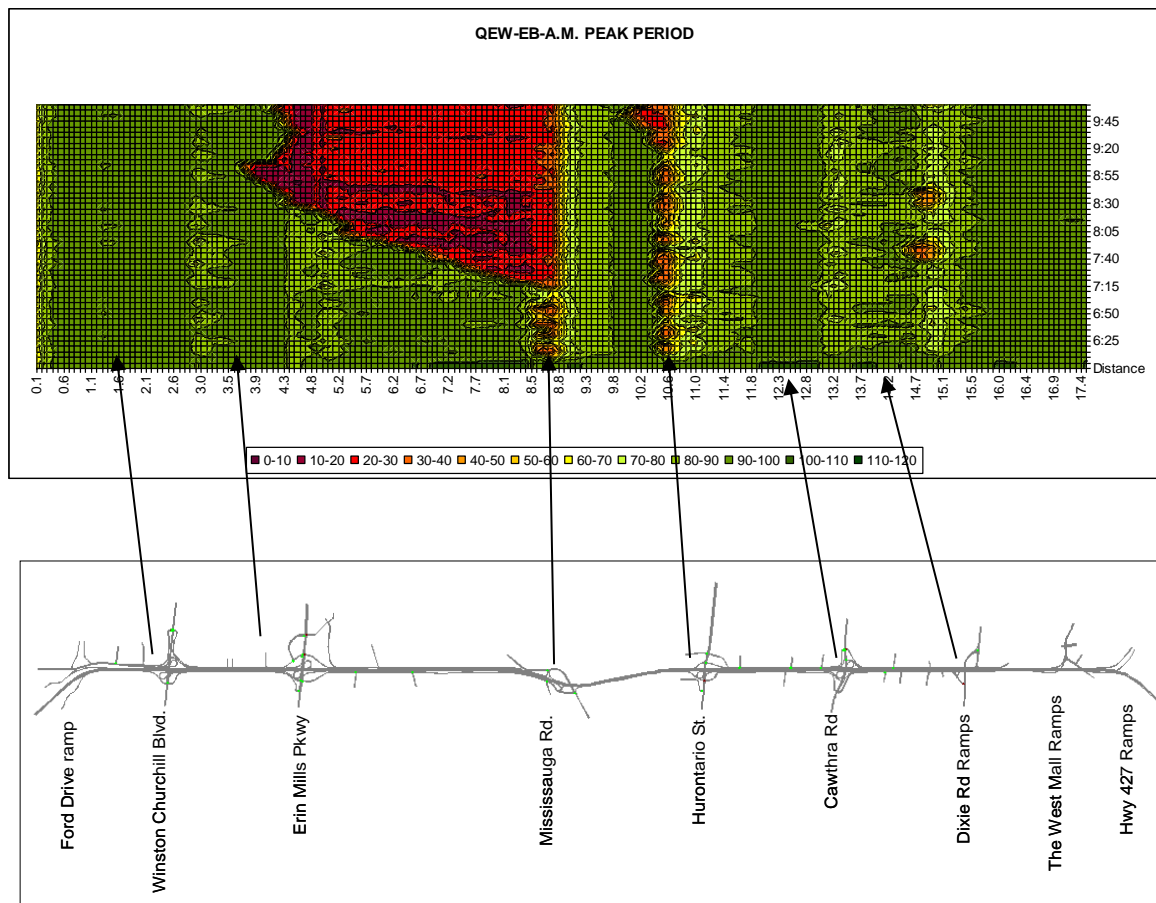
EXHIBIT 4-11: EXISTING EASTBOUND QEW AM PEAK PERIOD OPERATING SPEEDS

As presented in **Exhibit 4-11**, the eastbound traffic during the morning peak period is very congested and in a ‘stop and go’ condition, especially immediately west of Mississauga Road. The following three issues were noted at the QEW Mississauga Road Interchange, which results in poor levels-of-service in the eastbound direction and at the interchange ramp terminals:
